NBSIR 87-3546

Corrosion Evaluation of Underground Telephone Cable Shielding Materials

J. L. Fink, D. Mathews, G. Hessler, and E. Speed

January 1988

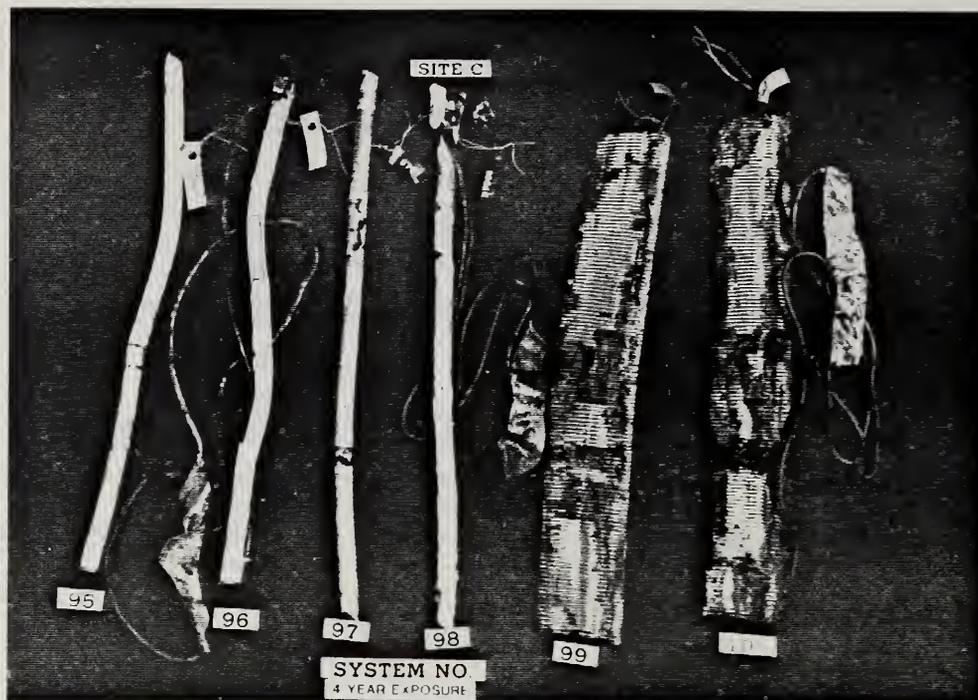
Figure 2. Outer Shield: Systems 95, 96, 97, 98, 99, and 100, left to right, exposed at Site C for four years. Severe corrosion on Systems 98 and 100 at window and/or ring areas, with severe corrosion on System 96 at all areas.

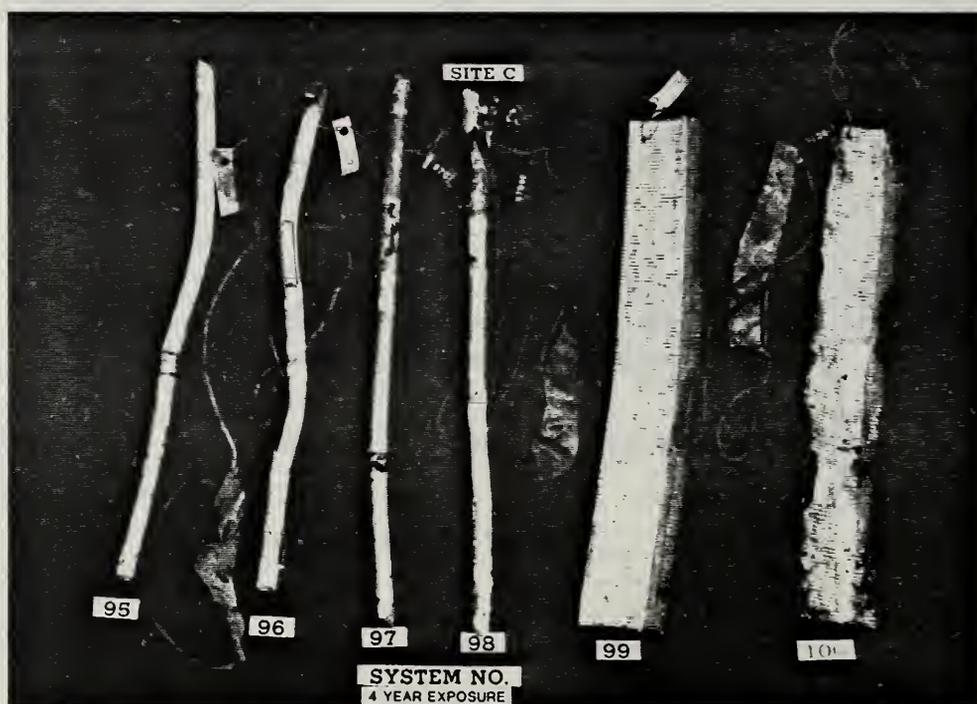
Figure 3. Outer Shield: Systems 95, 96, 97, and 98, Inner Shield: Systems 99 and 100, left to right, exposed at Site C for four years. Severe corrosion on System 98 at the window and ring areas, with severe corrosion on System 96 at all areas.

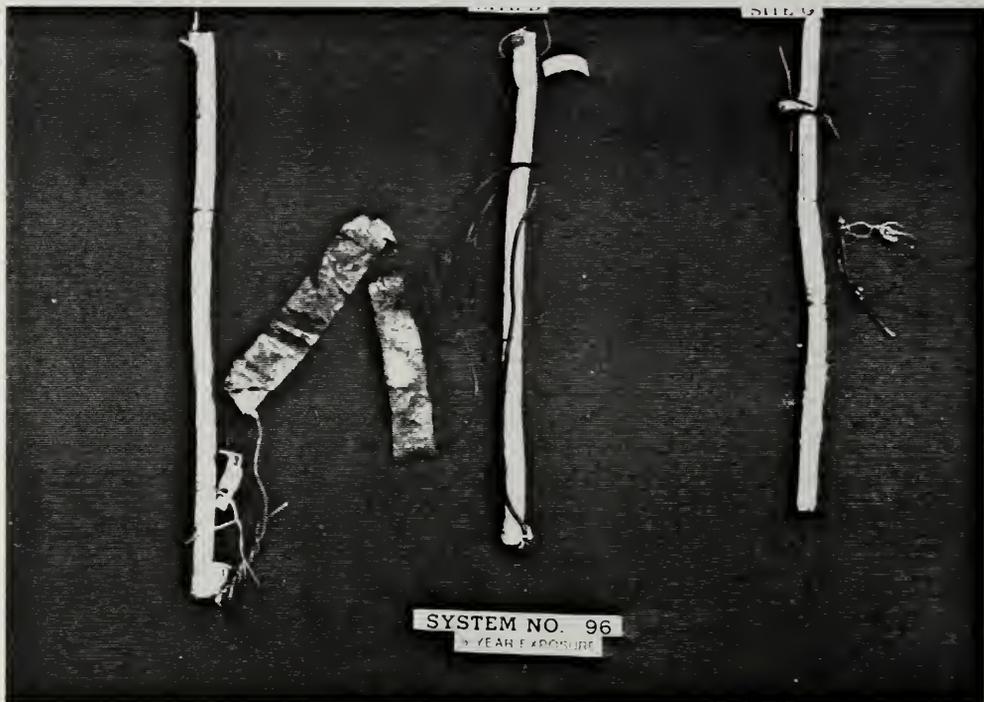
Figure 7. Outer Shield: System 96, Sites B, D, and G, left to right, exposed for five years. Coupling this system to copper accelerated corrosion on the specimens from all sites.

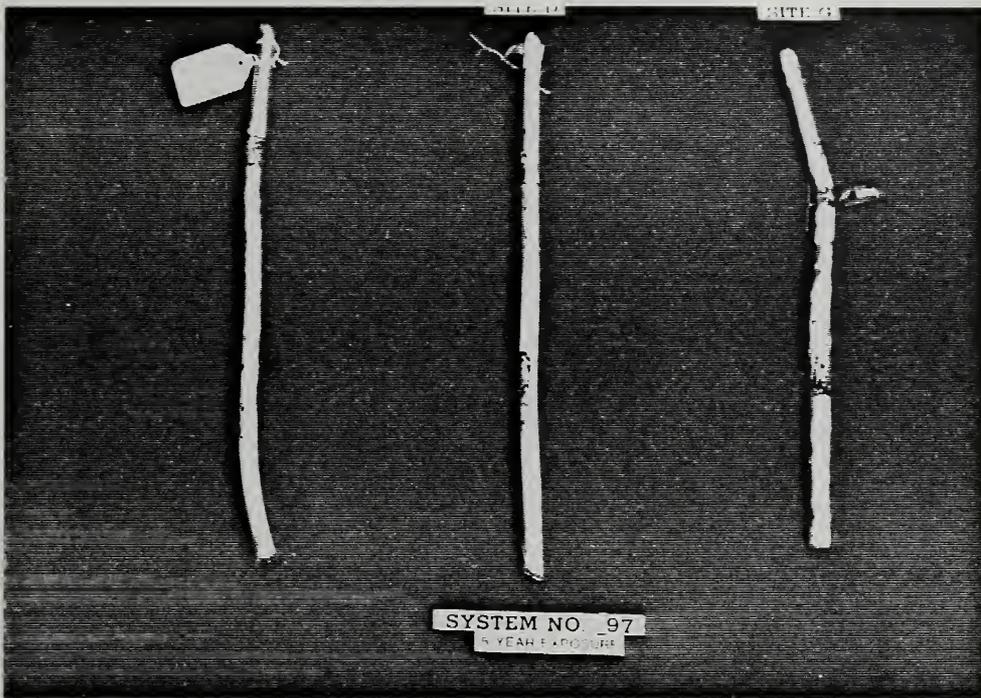
Figure 8. Outer Shield: System 97, Sites B, D, and G, left to right, exposed for five years. Degradation at the window and ring areas on the specimen from Site G was severe.

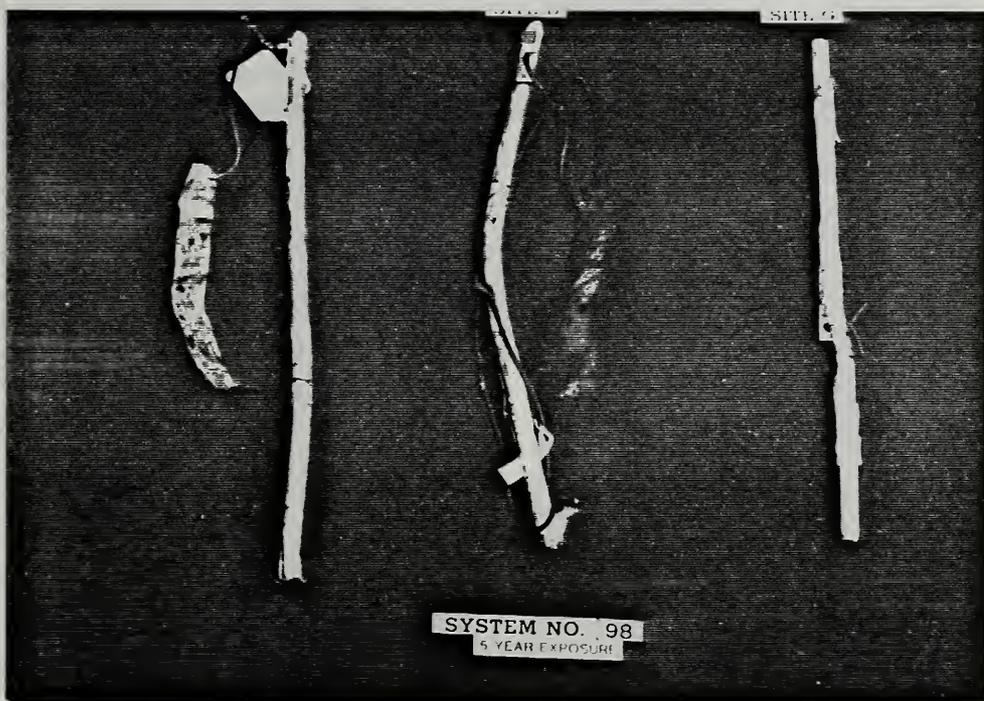
Figure 9. Outer Shield: System 98, Sites B, D, and G, left to right, exposed for five years. Coupling this system to copper accelerated degradation at all areas on specimens from all sites.

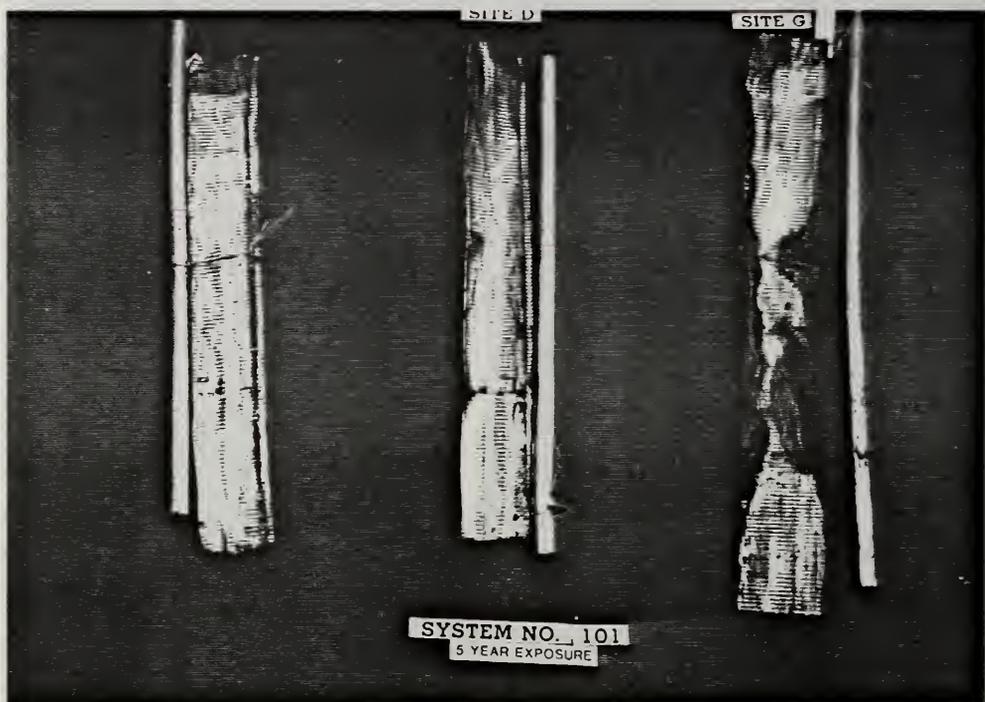
Figure 15. Inner Shield: System 101, Sites B, D, and G, left to right, exposed for five years. Dark areas indicate severe corrosion at the window and ring areas on the specimen from Site G.

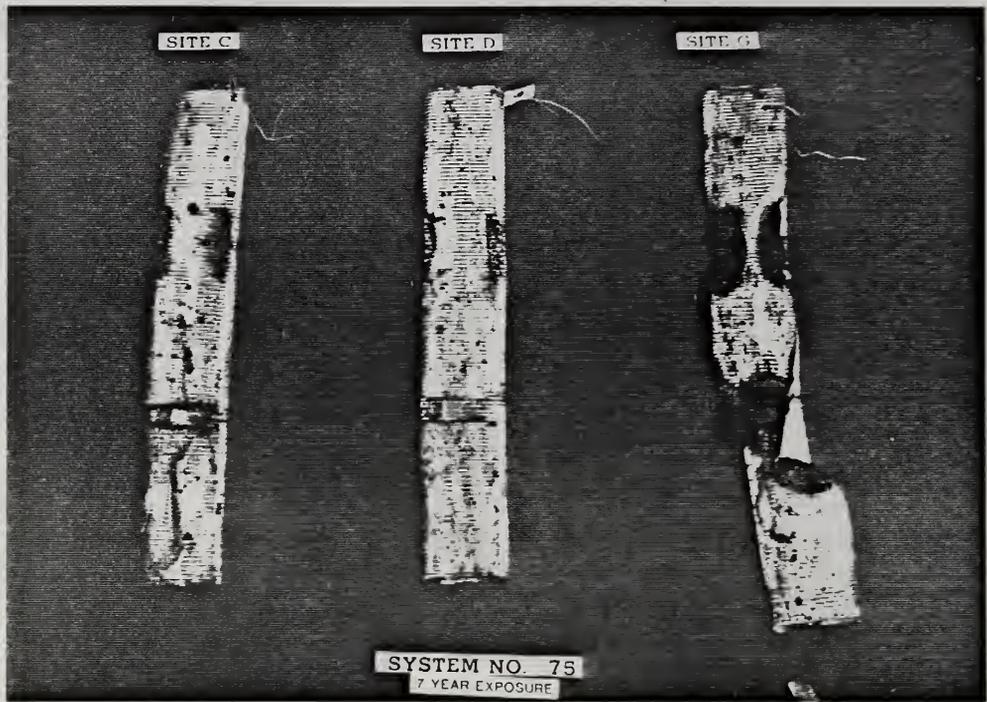
Figure 21. Outer Shield: System 75, Sites C, D, and G, left to right, exposed for seven years. Dark areas indicate severe corrosion at all areas on the specimen from Site G.

System 75. The inner aluminum alloy shield on specimens of this system (Table 1) exposed for up to four years at Sites B and E and for seven years at Sites C, D and G were unaffected by corrosion. The outer steel shield on specimens buried at Sites C, E, and G for one year, Sites A and B for up to two years, and Site D for up to four years was also unaffected by corrosion. Corrosion was superficial or nil on specimens buried at Site E for up to four years.

With one exception, corrosion at all areas examined on both shields was nil on specimens buried for one to three years at Site C. The outer shield showed slight corrosion at all areas examined after two years of exposure at the same site, while only the window and ring areas showed slight corrosion after four and seven years of exposure. The specimen exposed for seven years at Site D indicated slight corrosion of the outer shield at only the window and ring areas. At Site G the window area was near ELD for the specimens buried for two and four years and near ELD at and adjacent to the ring area after three years exposure. The specimen buried for seven years at Site G was ELD at all examined areas.

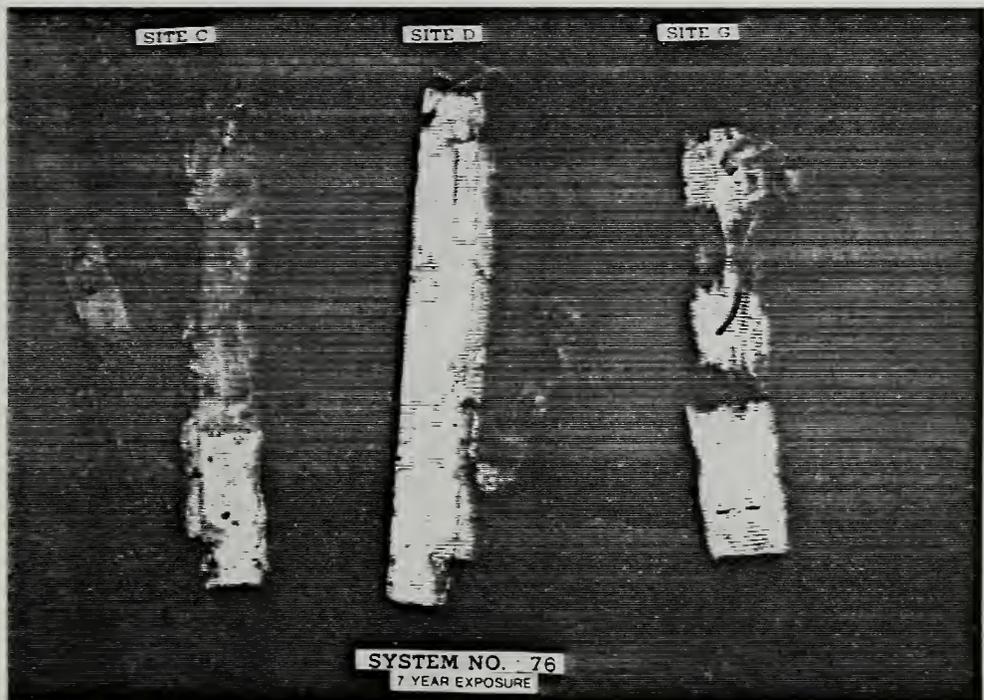
Figure 24. Inner Shield: System 76, Sites C, D, and G, left to right, exposed for seven years. Coupling this system to copper accelerated degradation at all areas on the specimens from Sites C and G.

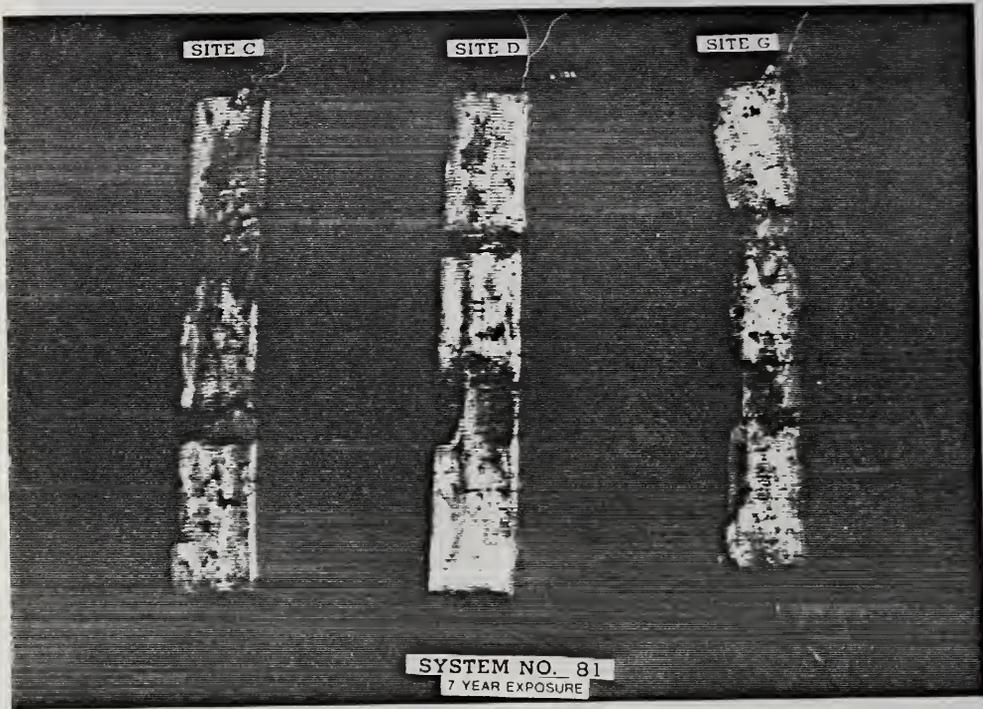
Figure 33. Outer Shield: System 81, Sites C, D, and G, left to right, exposed for seven years. Dark areas indicate severe corrosion at all areas on specimens from Sites C and G.

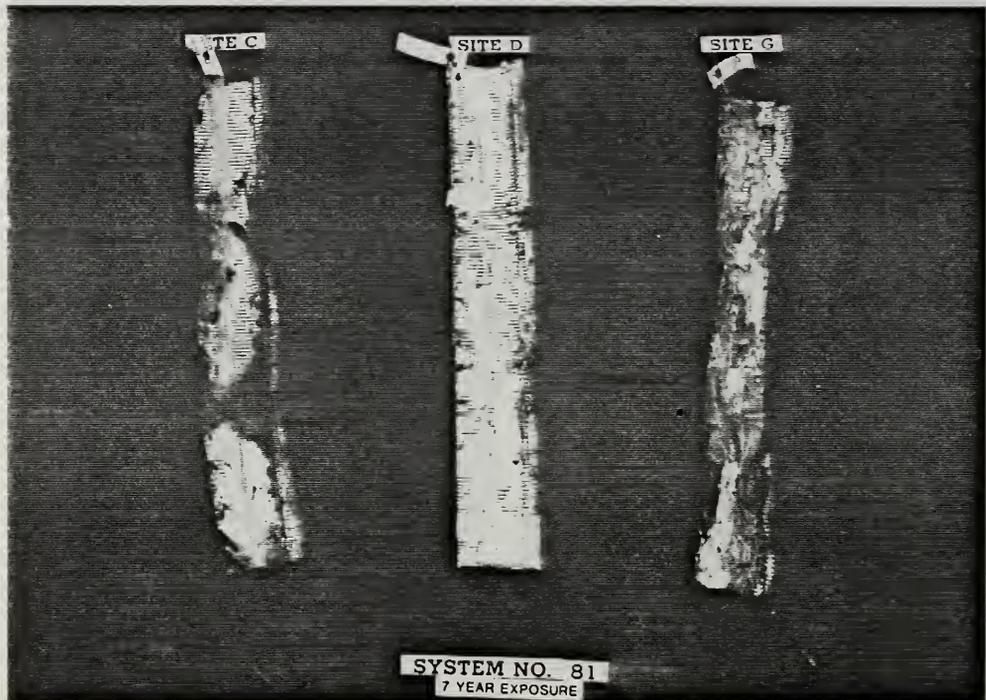
Figure 34. Inner Shield: System 81, Sites C, D, and G, left to right, exposed for seven years. Severe degradation at the window and ring areas on the specimen from Site C, with severe degradation at all areas on the specimen from Site G.

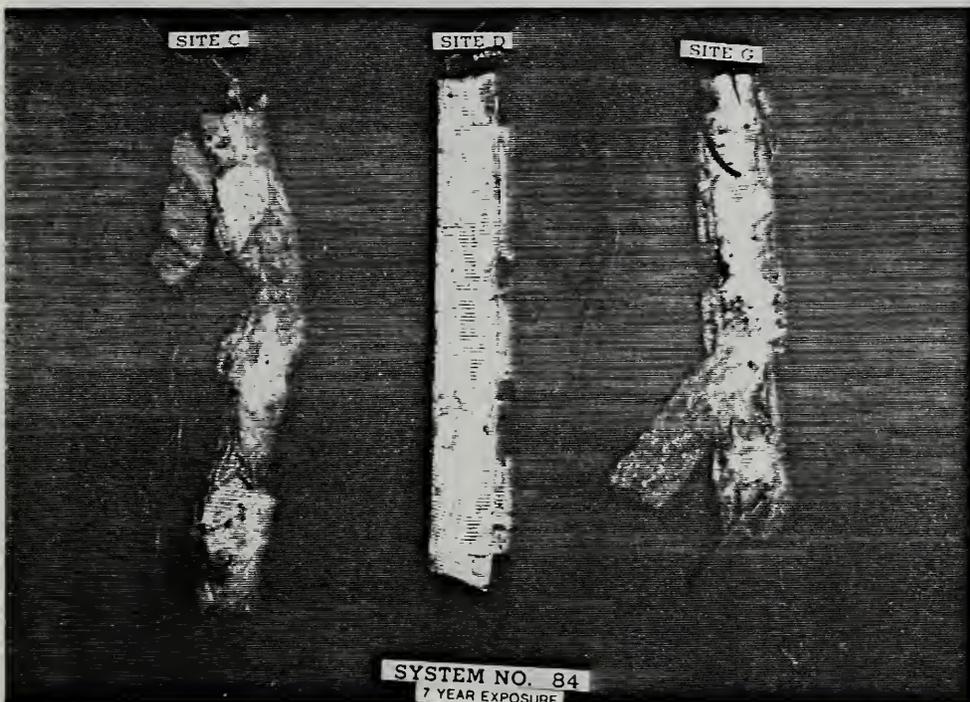
Figure 40. Inner Shield: System 84, Sites C, D, and G, left to right, exposed for seven years. Severe degradation at all areas on specimens from Sites C and G.

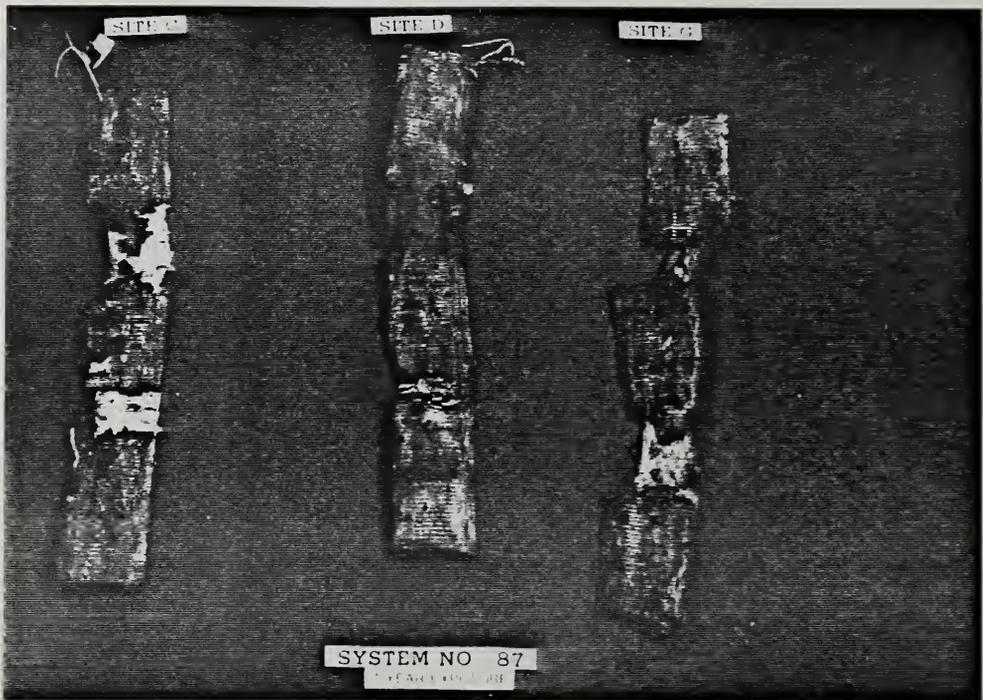
Figure 45. Outer Shield: System 87, Sites C, D, and G, left to right, exposed for seven years. Severe corrosion at the window and ring areas on the specimen from Site D, with severe corrosion at all areas on specimens from Sites C and G.

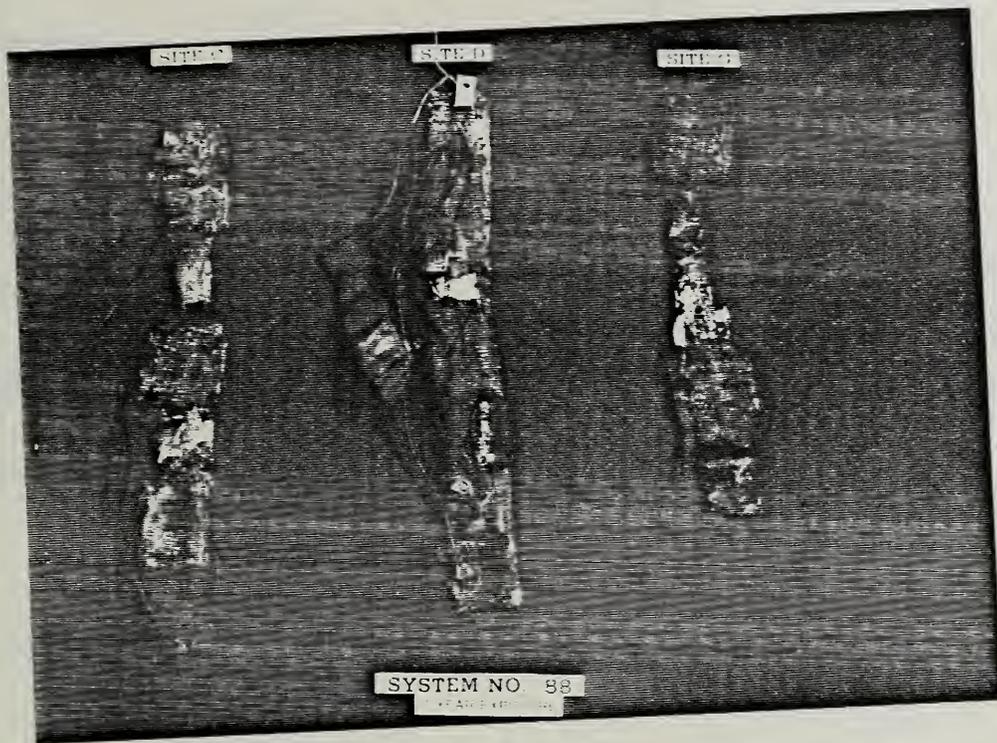
Figure 47. Outer Shield: System 88, Sites C, D, and G, left to right, exposed for seven years. Coupling this system to copper accelerated corrosion severely at all areas on all specimens.
